FERMILAB-TM-2074

**Report on Booster High Pulse Repetition Rate Operation Tests
Conducted on March 29, 1998**

Robert C. Webber

March 1999

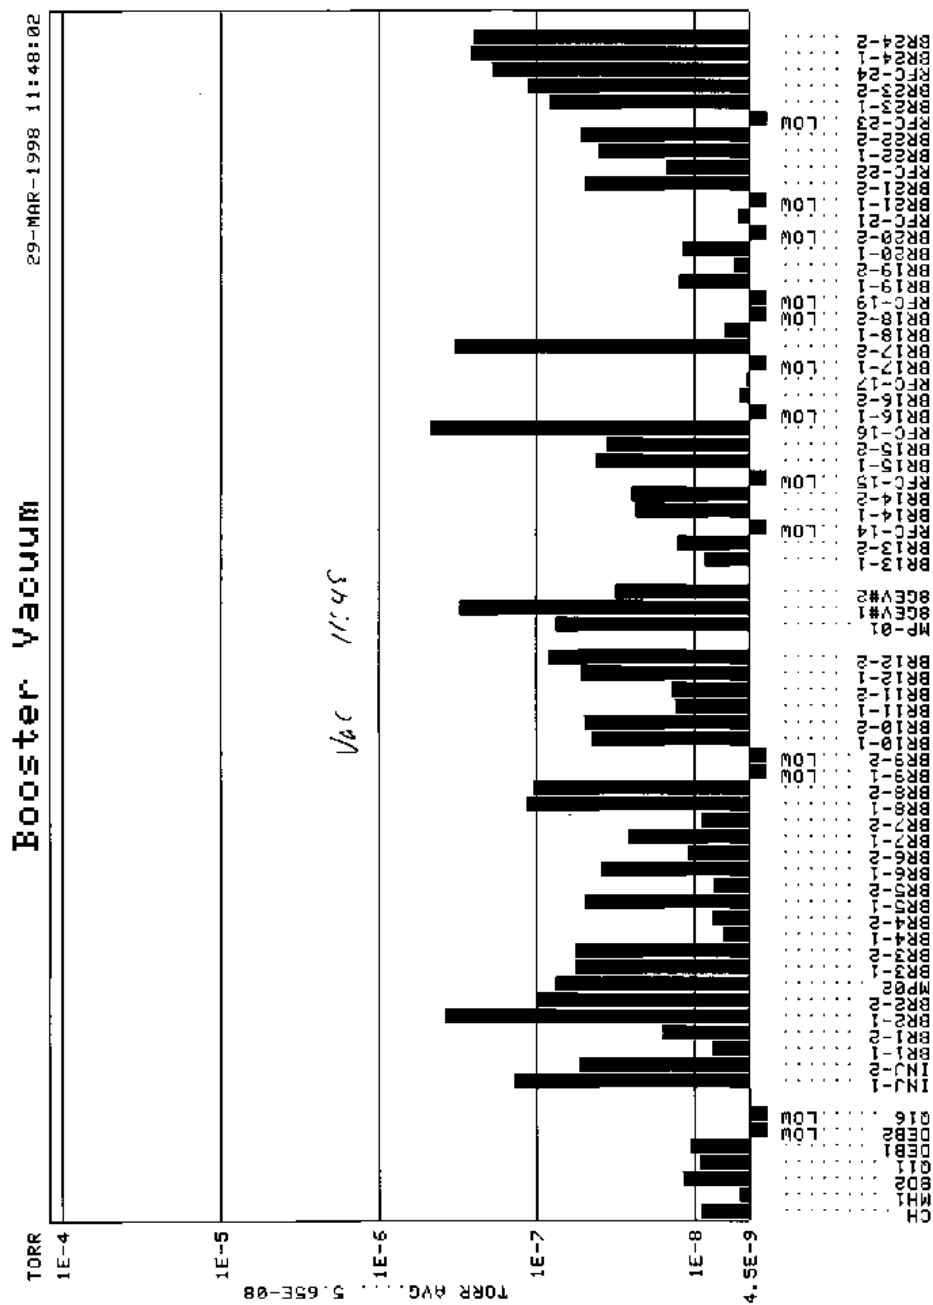
Figure 5. Booster vacuum two minutes into Booster high pulse repetition rate test.

Figures 5 and 6 show plots of the ring vacuum early in the tests and one hour into the tests respectively. Notice higher pressures around MP01 and the Long 13 area early in the tests before MP01 was turned off and then higher pressures around the injection region in the later plot as the ORBMP magnets heated. After two hours of operation with this timeline no additional vacuum problems were identified. Approximately 90 minutes into the test period, beam was momentarily switched on and observed to still accelerate through the Booster; this, of course, is the true test of all the systems.
